**SOUTHWESTERN COASTAL BASIN
GREENWICH, CONNECTICUT**

**PEMBERWICK DAM
CT 00042**

**PHASE 1 INSPECTION REPORT
NATIONAL DAM INSPECTION PROGRAM**

FEBRUARY, 1980

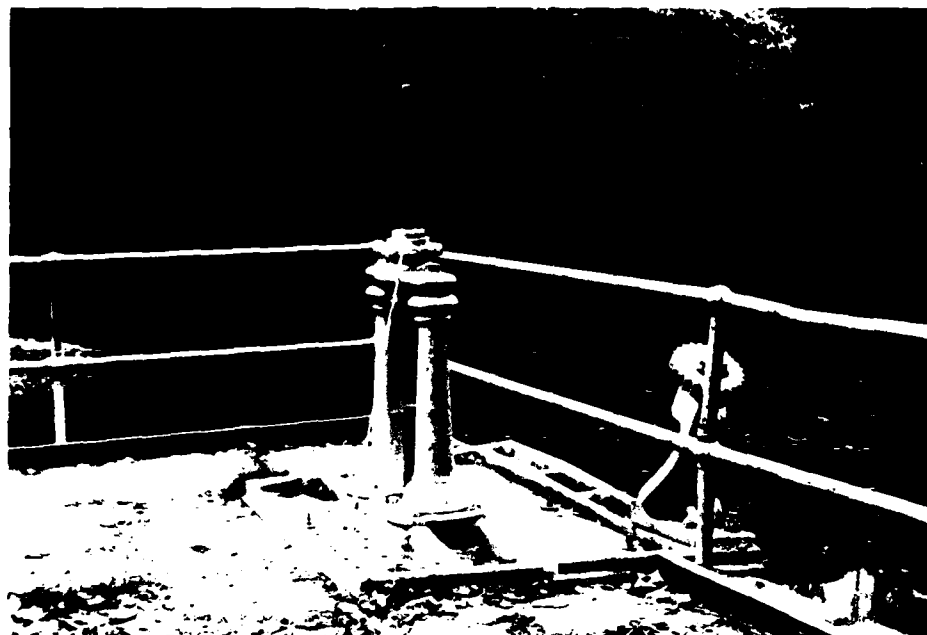
The outlet works, consisting of pipes through the dam, have been inoperable for many years. The high level outlet was sealed in 1978 to control leakage and the inlet for the low level outlet is suspected to be below the present sediment level.

C-5 OUTLET WORKS CONTROL MECHANISM
